# **The Swansea Slip Bridge**

*A local structure of Special Historic Interest*

**9 May 2007**

## The Swansea Slip Bridge, St Helen's, Mumbles Road, Swansea.

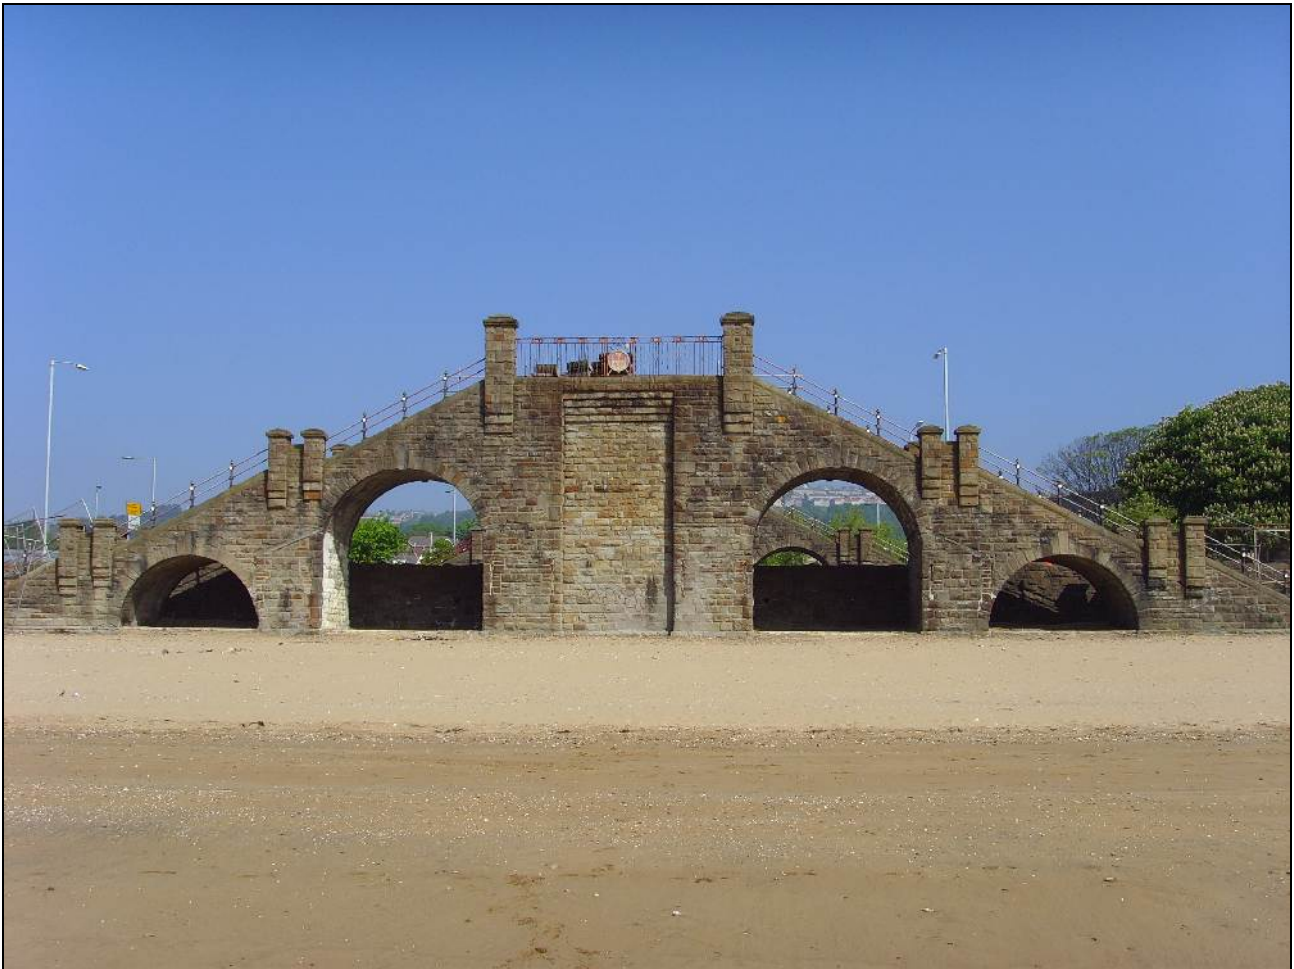
## 1. The seaward facing pennant sandstone abutment.

The highly distinctive seaward side abutment has successfully weathered nearly a century of tides, sand and weathering. It is a remarkable landmark structure which is visible from almost everywhere on the sweep of the bay. It is different in size and shape to the smaller landward abutment. The structure is constructed from high quality pennant sandstone and remains in good condition despite neglect by the owners.

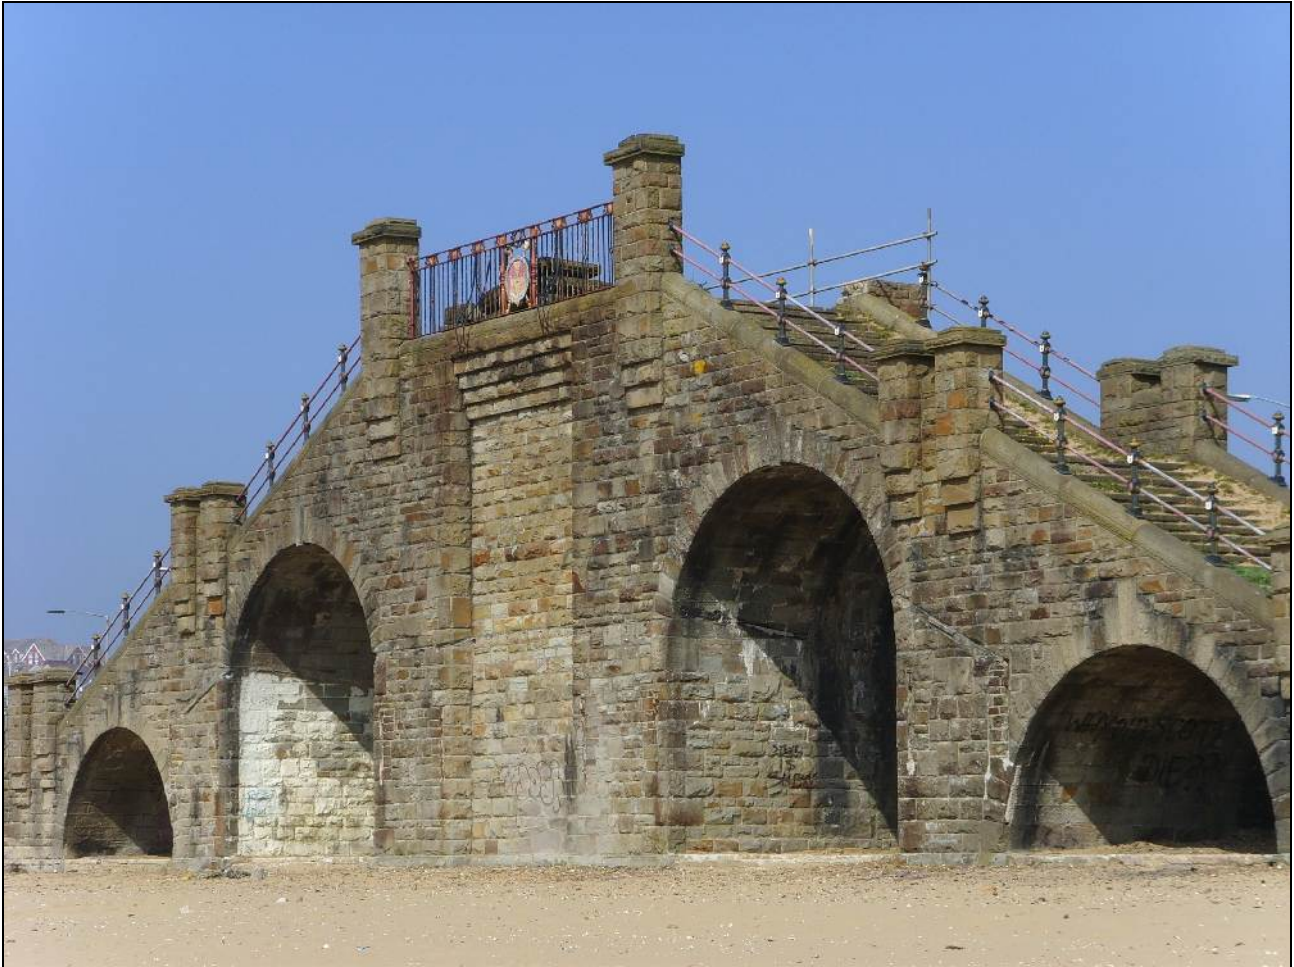
## 2. The Seaward abutment from the eastern side.

The stonework is of very good quality and although it has been argued that the steel deck had far exceeded its safe lifespan, the same is not true of the stone abutments. The County Council's refurbishment report of 2004 acknowledged that the stonework is in good condition. It is evident that the small deterioration that has occurred is a result of the withdrawal of maintenance by the Council rather than any problem with the structure.

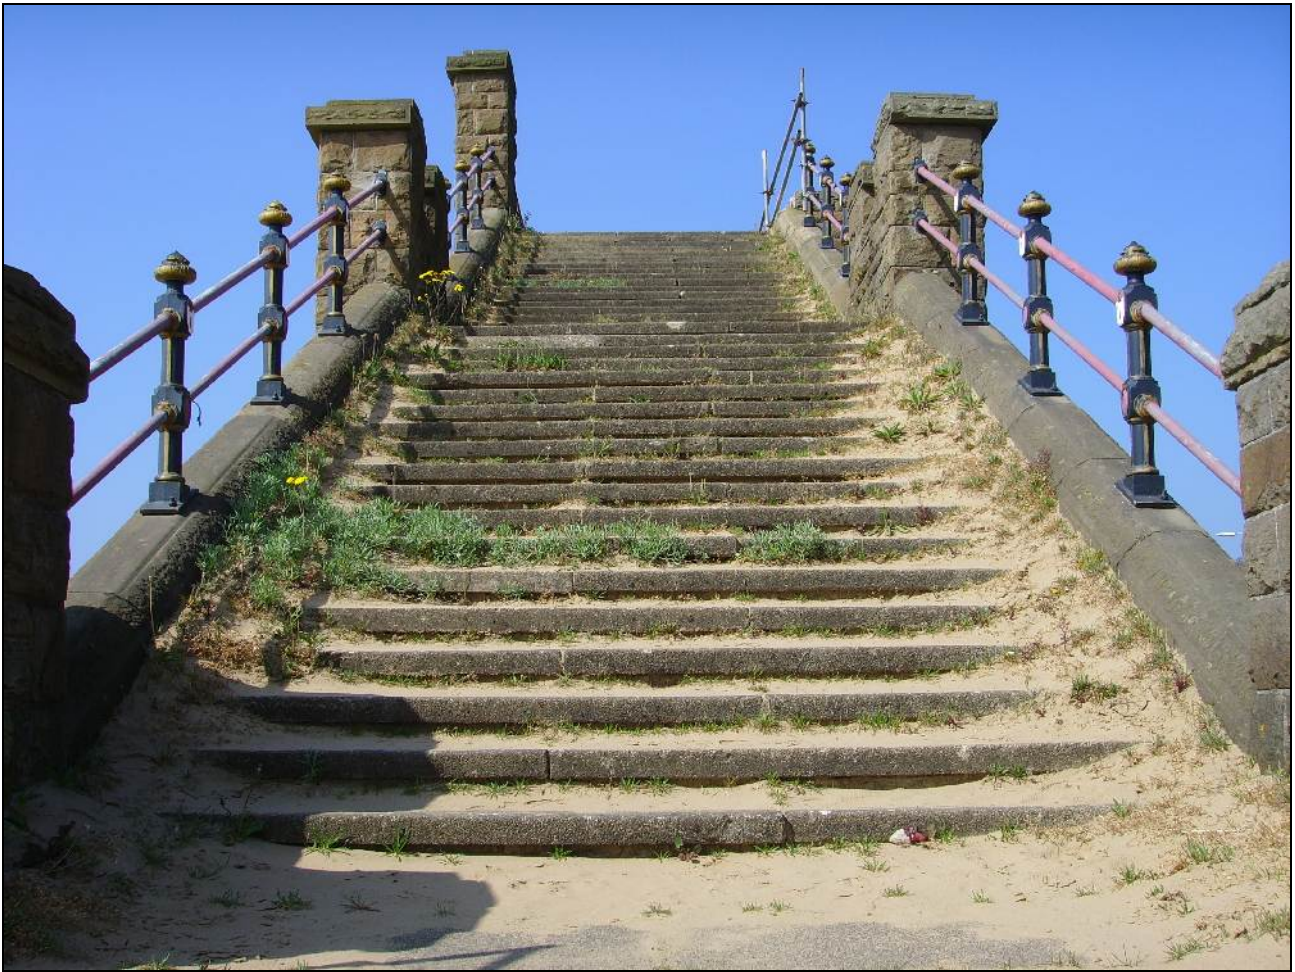
### 3. The seaward eastern side stairway.

Much of the dilapidation here is simply because the bridge has been fenced off from regular use. The structure has coped admirably with drifting sand and the elements for almost a century. The establishment of vegetation on some of the steps is likely to threaten the integrity of the structure very quickly. This picture also gives some appreciation of the massive structure of the abutments. The original builders were clearly intent on building a high quality structure that was going to last for a long time.

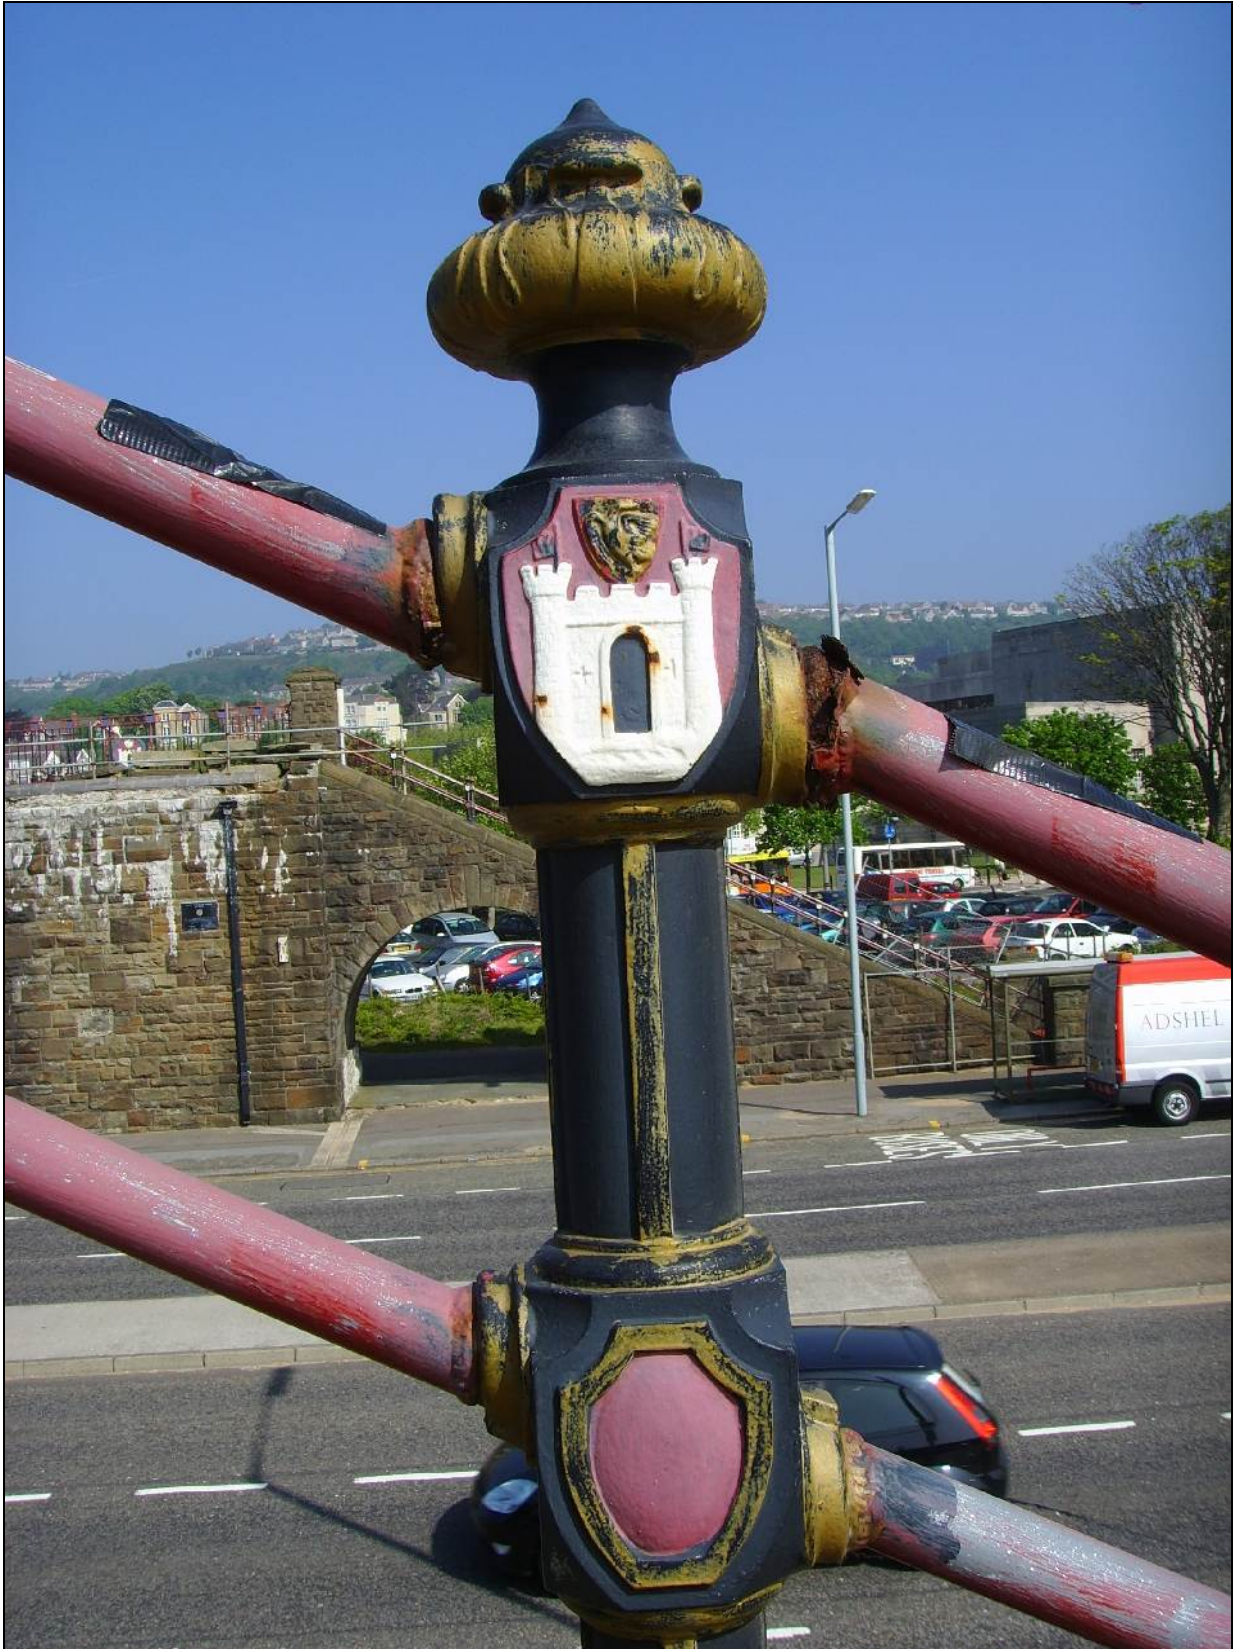
#### 4. Close up of a cast iron column

This column still shows the painting of the last refurbishment exercise in 1994 which was completed with great care and attention by West Glamorgan County Council. The arms on the column are a particularly fine representation of the arms of the County Borough of Swansea. The detail even goes down to the fish in the beak of the osprey.

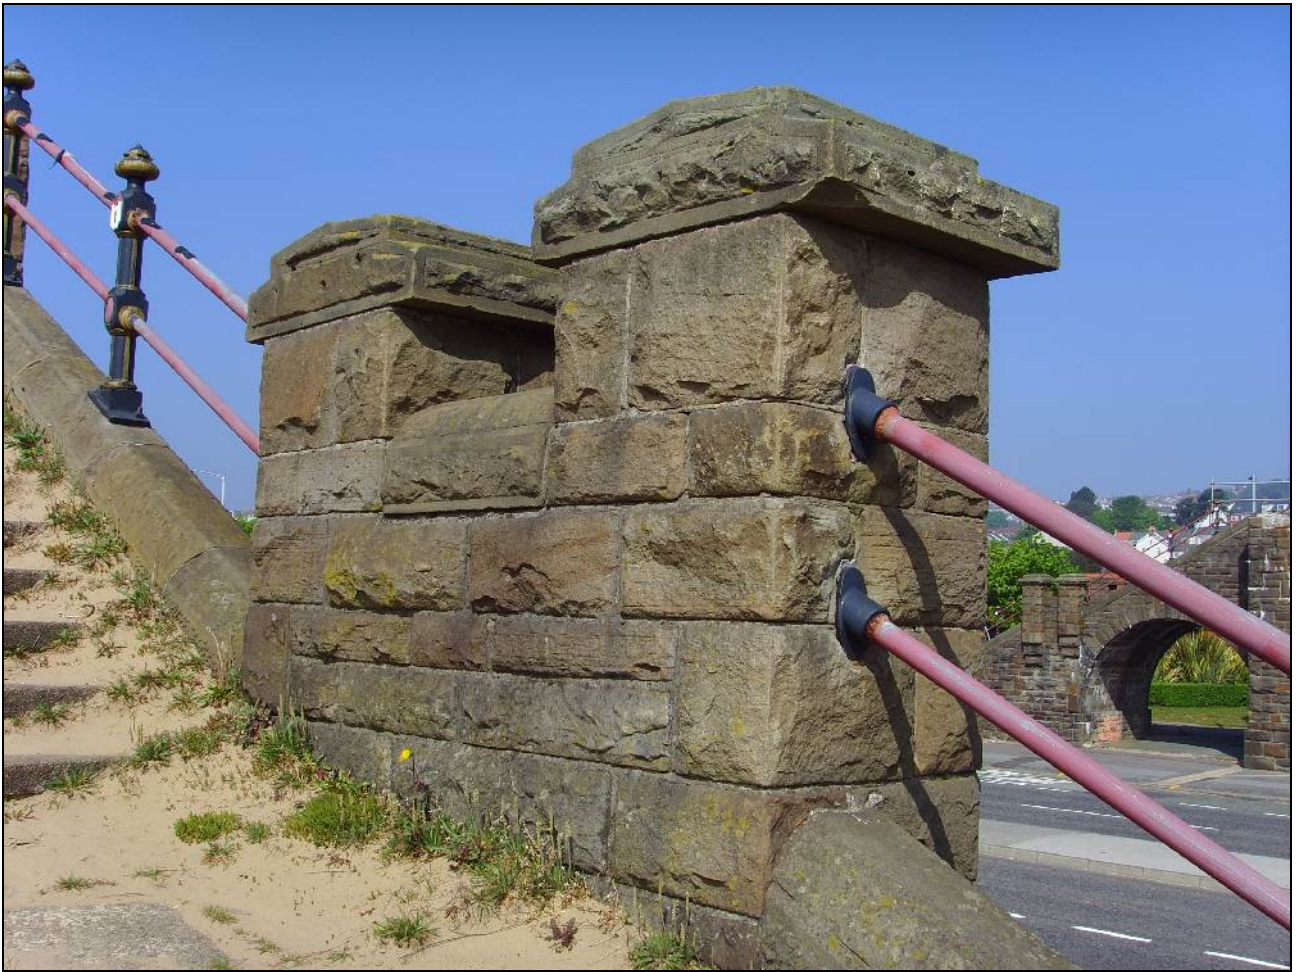
## 5. Pennant sandstone detail

Most of the remaining structure is of high quality stonework which reflects the status of the original structure. It is in good to excellent condition and would cost over £800,000 to replicate today.

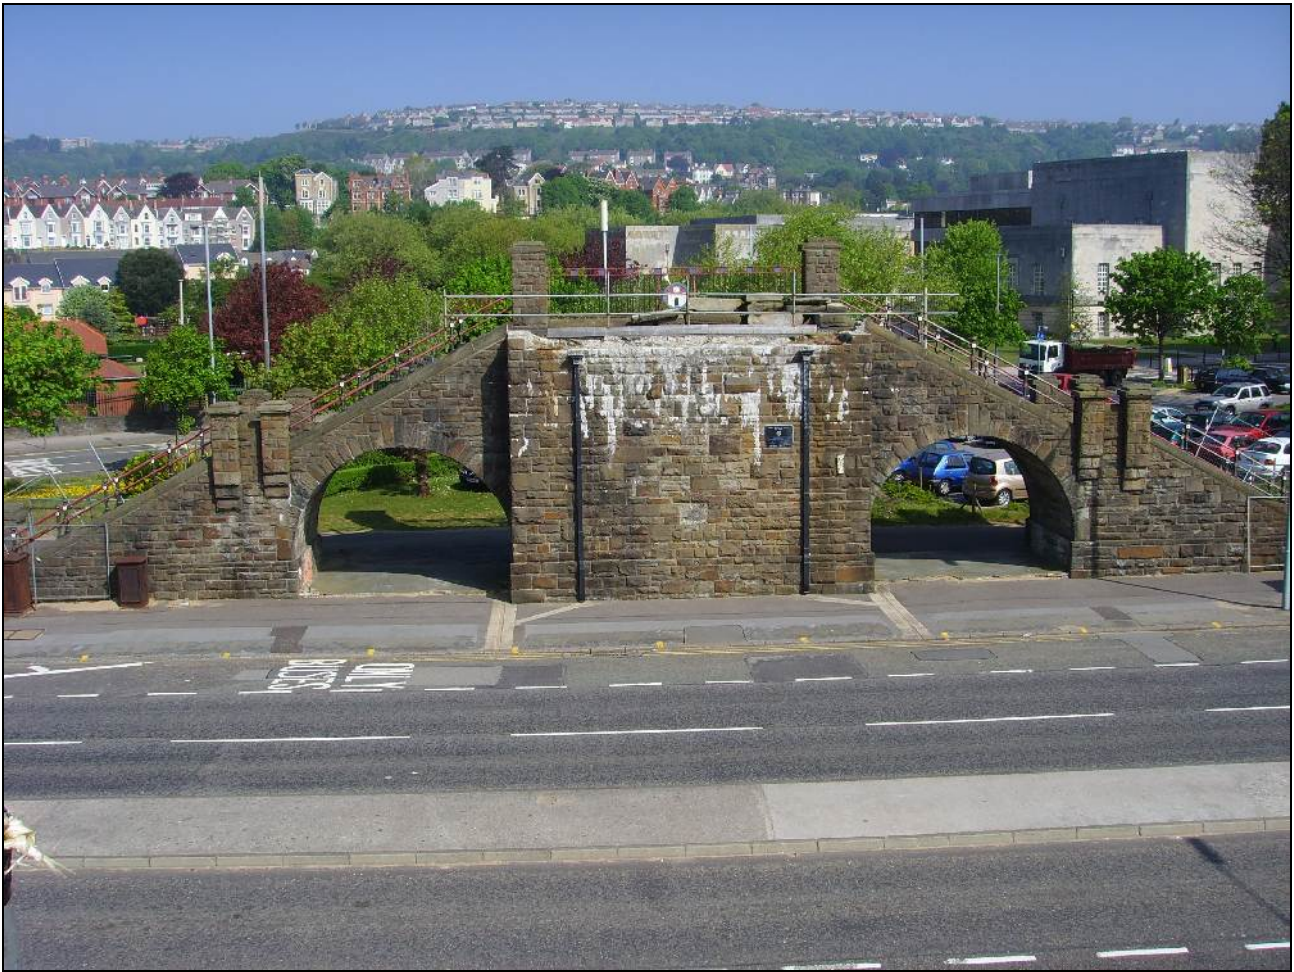
## 6. The landward abutment

A view looking across to the landward abutment. The good repair of the stonework is evident. The removal of a number of ancillary structures in the arches have revealed the full grace of the structure. The right hand side arch contained a small beach side café for many years. Several of the re-use plans have a theme of using the arches as a basis for redevelopment. In the background is the Grade 1 listed Swansea Guildhall. Just behind the abutment on the left hand side are the remnants of the small botanical garden that used to compliment the setting. Most of the garden was ripped up to provide additional car parking or has been left unkempt and still contains building rubble left over from the demolition of the high quality toilets that used to stand there.
